Maintenance Works Reporting – Sample Property

Sample property - Body Corporate -
Maintenance Works Reporting / 27 Jun 2022

Date 27.06.2022

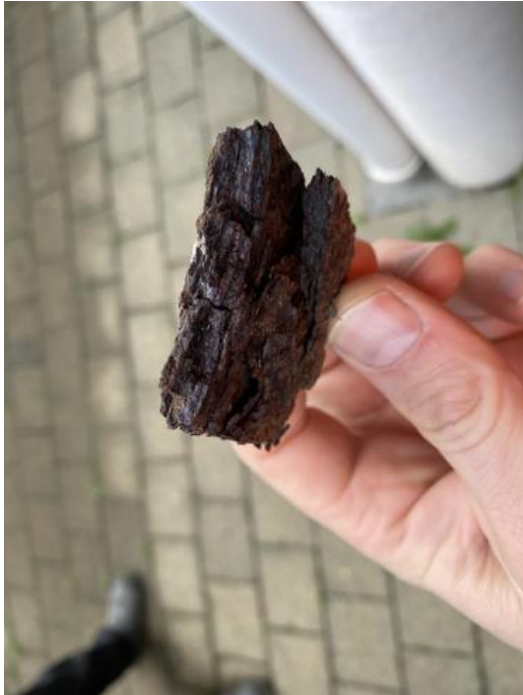
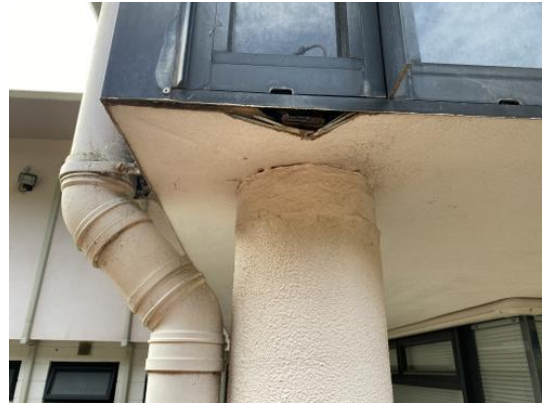
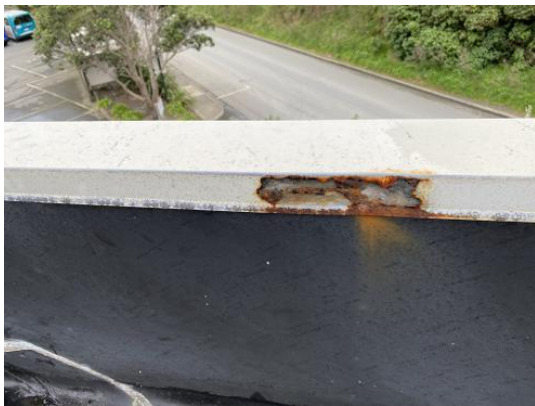
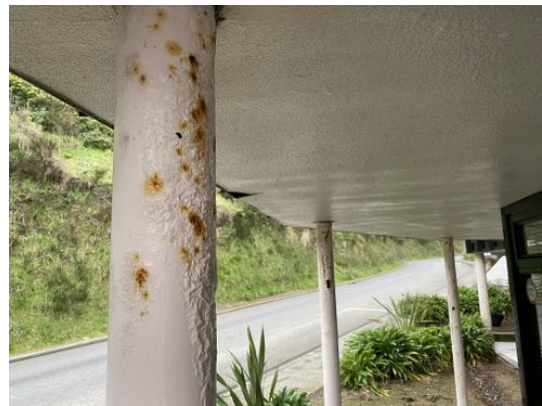
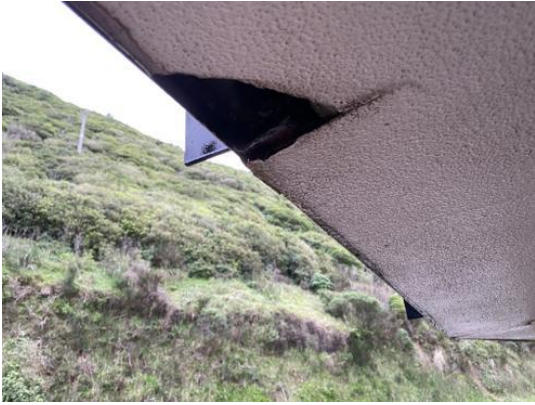
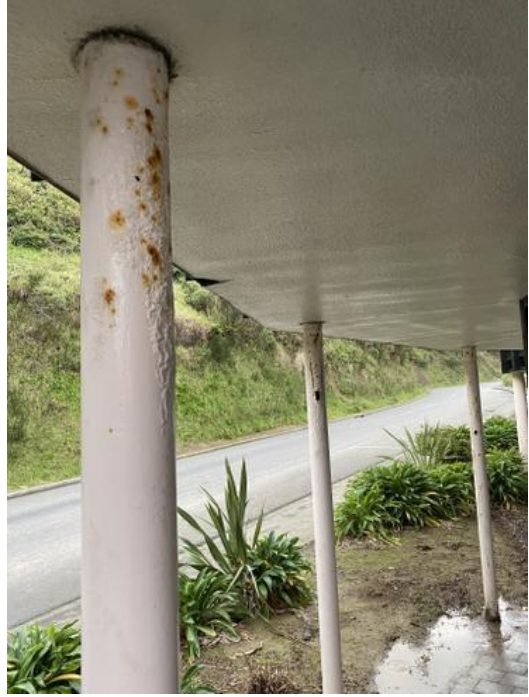
Water egress
Damaged or failed building materials;
broken, rotten or impact

There are a few areas around the Soffit of buildings that are exposed to the elements (as pictured). Have identified one area where water egress may be coming into this area, further investigations are advised as it appears this is steel elements in the frame work that are rusting and expanding and further damaging cladding. Please advise if you would like quotations for repairs here.

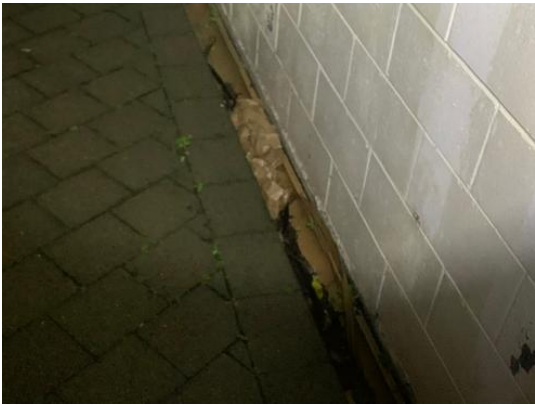
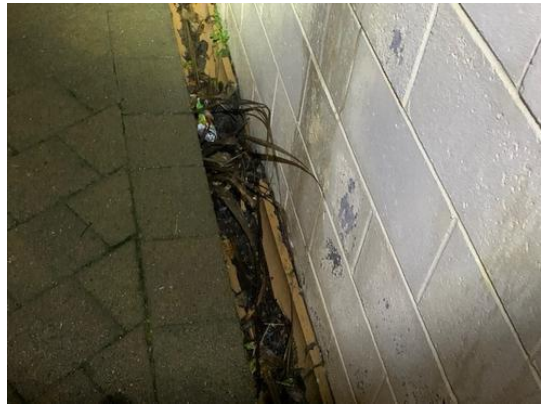
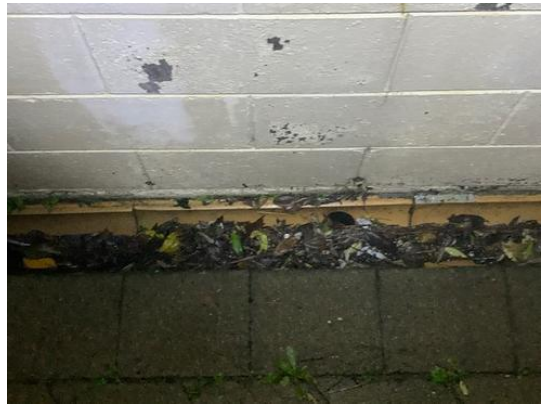
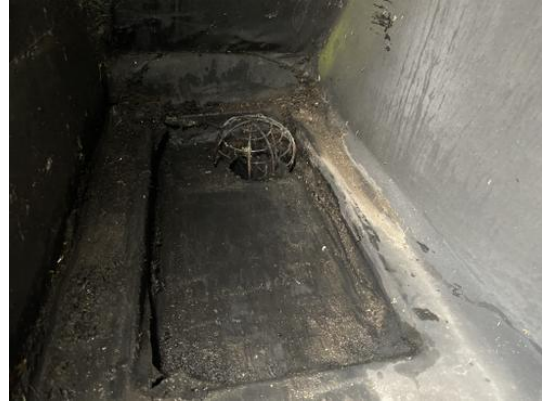
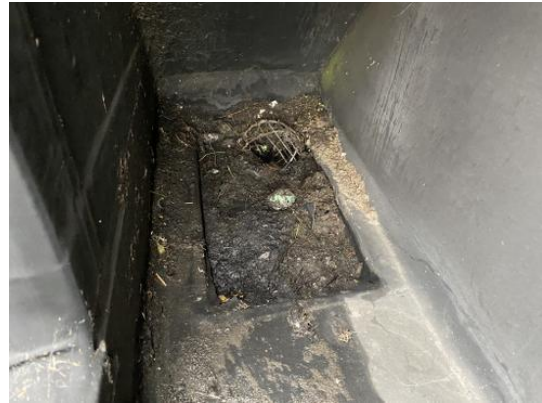
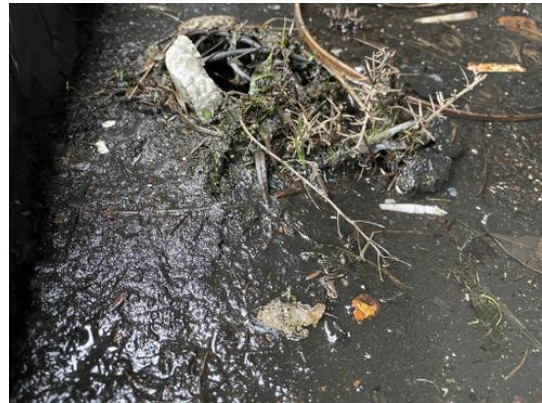
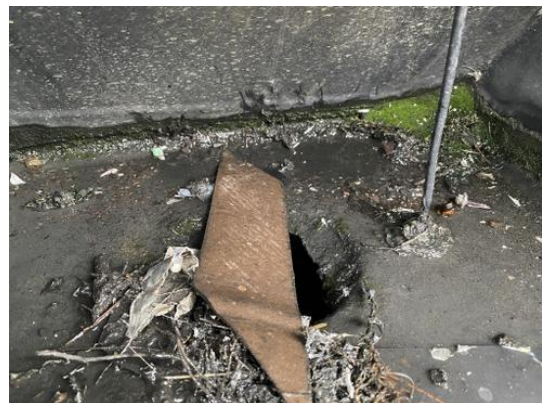
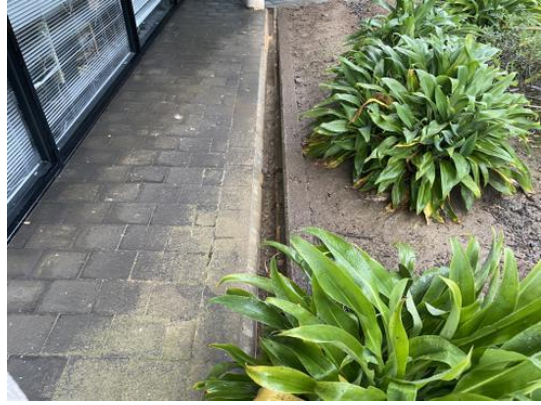
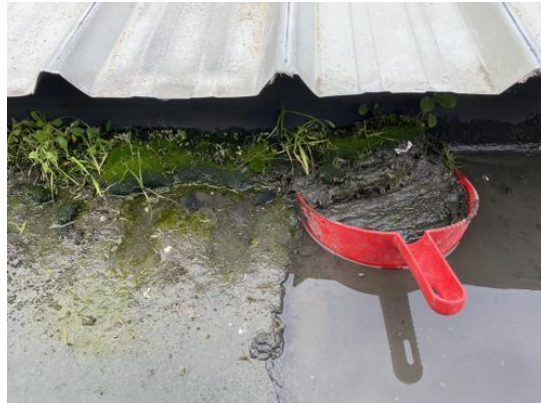
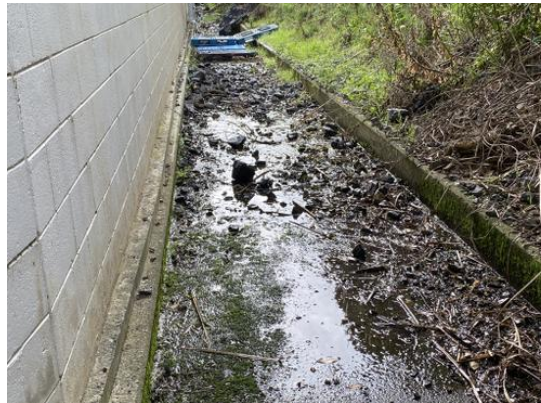
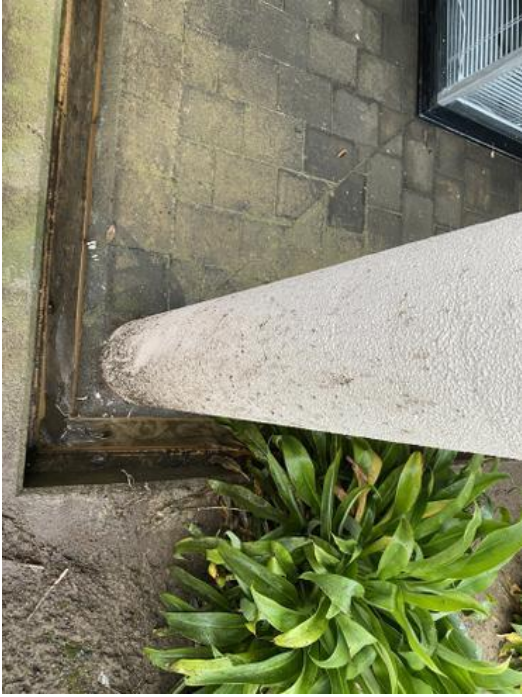
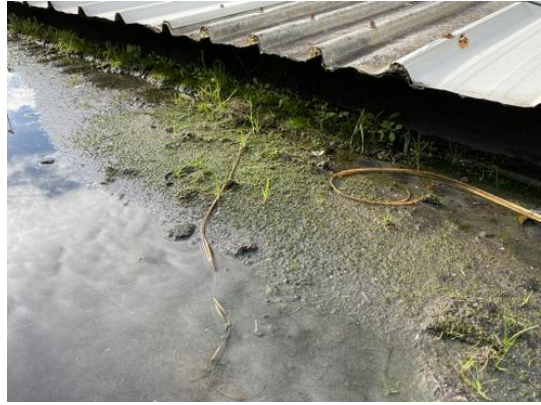
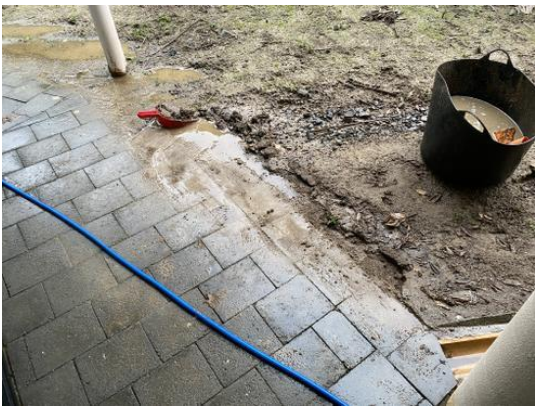
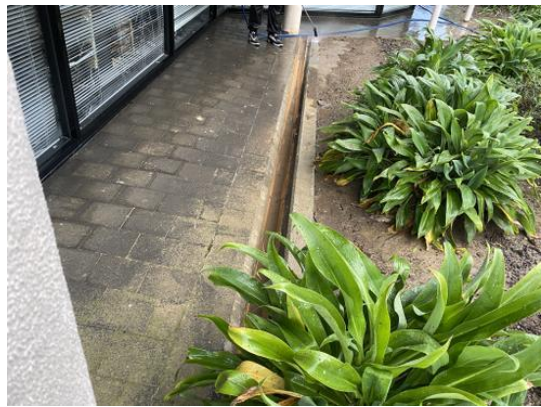
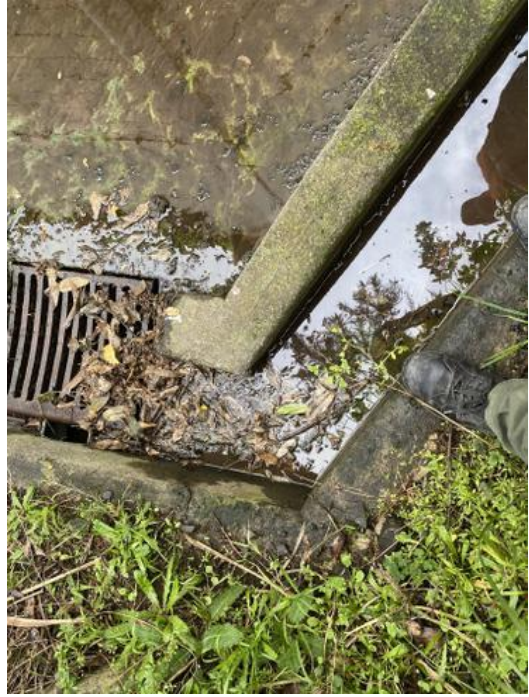
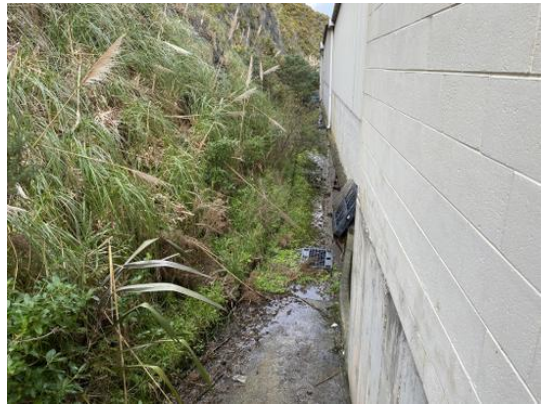
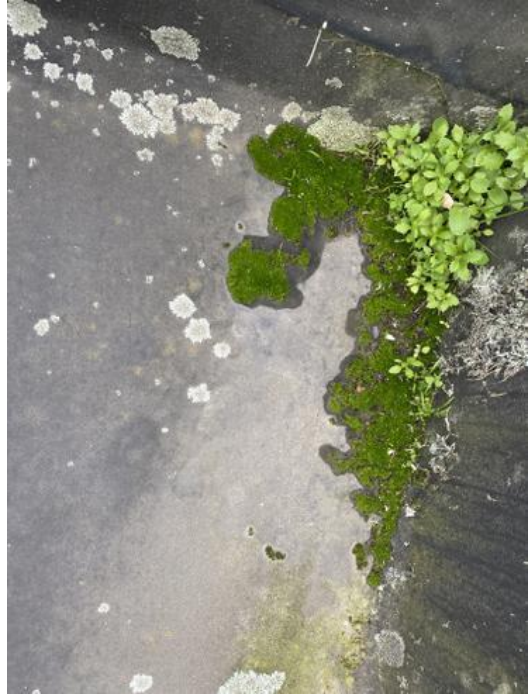
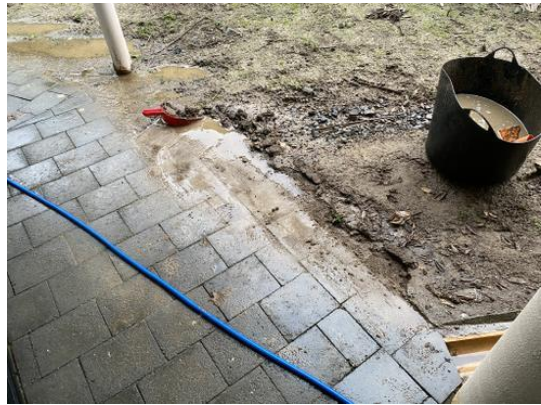
Blocked drain

Blocked guttering or downpipe

As discussed onsite, there are large areas of blockages from slips and Plant growth in the rear culvert of the building and will send through a quotation for removal works for this area.

- There were a few new blockages in the roof Guttering, all drains checked and have now been cleared maintained.

- Outside Unit 2 there is a drain that catches debris and dirt from the garden that was very blocked, have cleared. There is also one area here that is pooling water around the base of the structural posts here. Rust is forming in this area,. Suggest installing either a strip drain or novacoil here to move run off pooling to curb. Please advise if you would like new drainage installed?

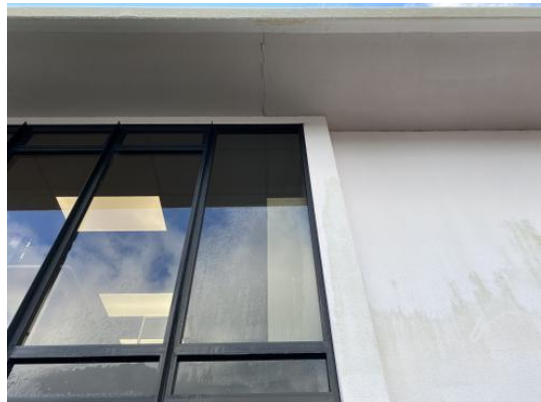
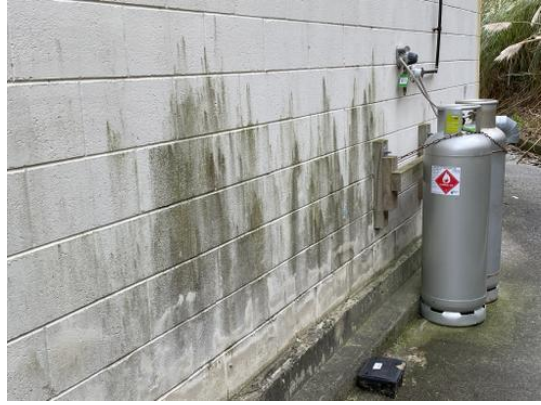
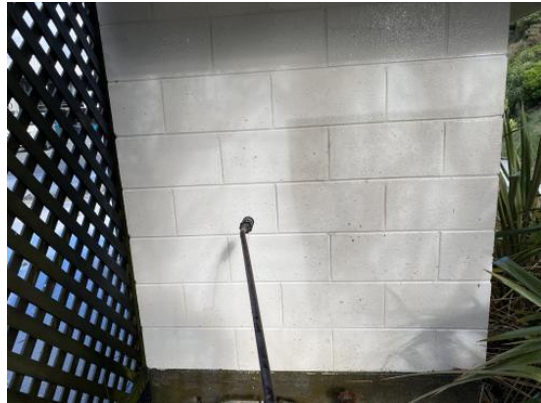
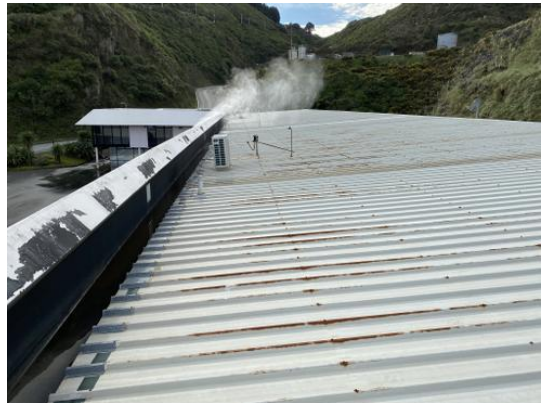
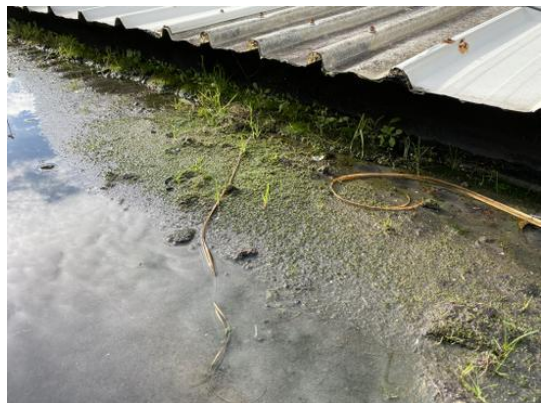
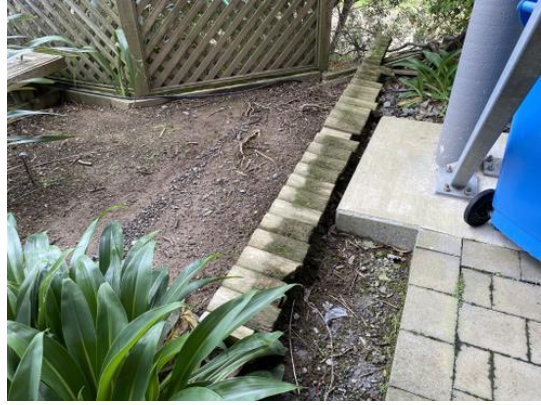
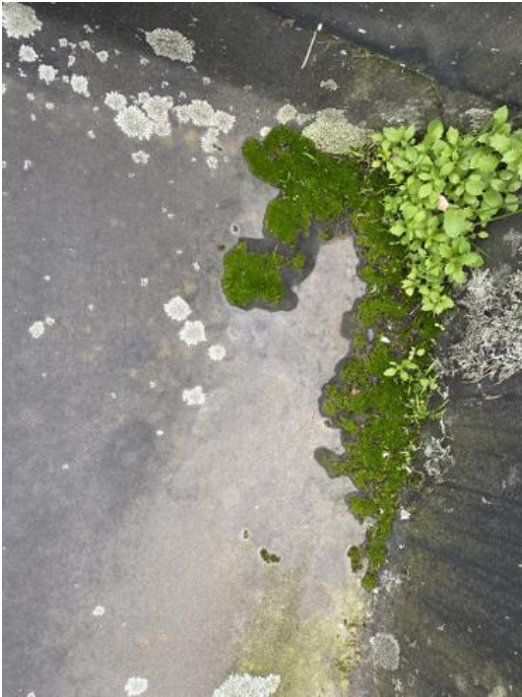
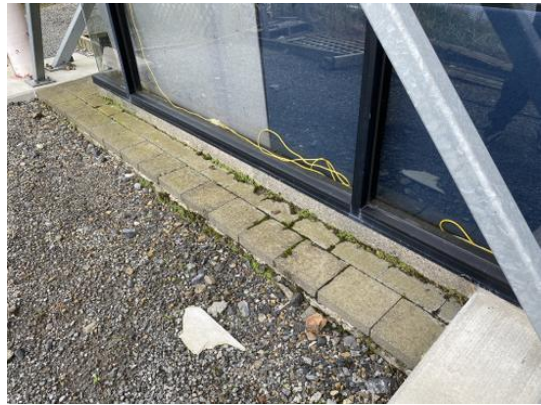
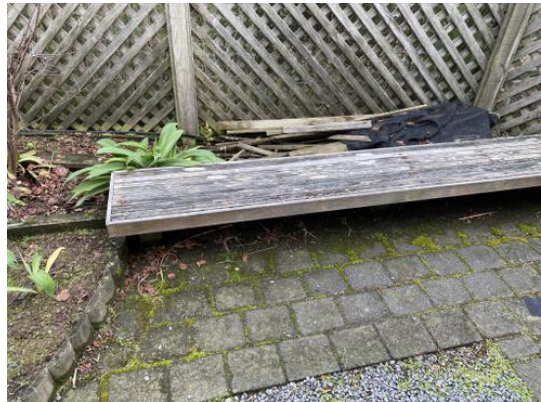
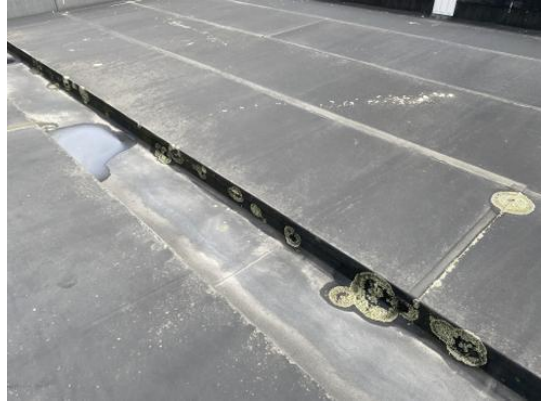
Fungal growth; moss mould or lichen growth

Environmental grime build up

- The rear sides of the building have very heavy fungal growth, we did a prewash treatment and post wash treatment here for you. Some staining persists. Particularly at south end of complex and above Unit 15, historical staining is present. There is also some areas of historical staining from black lichen above unit 5 and 8.

- We performed a courtesy clean of entrance way signage, pumphouse (some staining remains) and wall in front of unit 2

- Treated fungal growth to areas of roof

- The Southern Court yard pavers had lots of moss growth, we have put an antifungal treatment on this area.

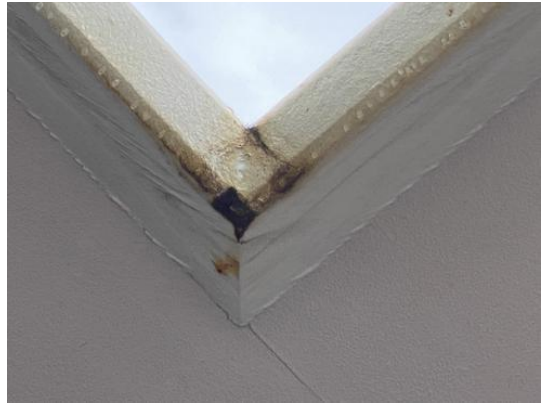
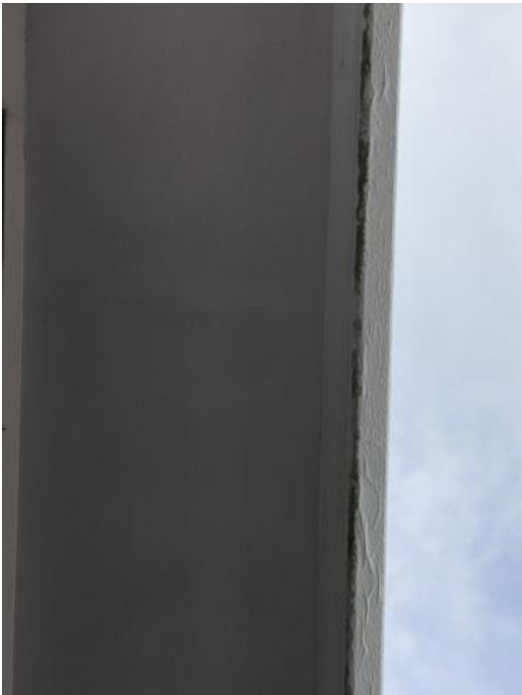
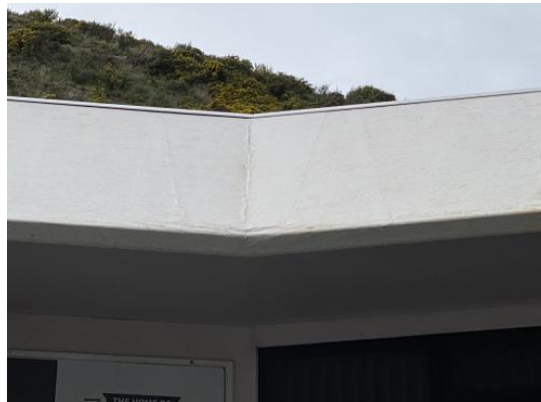
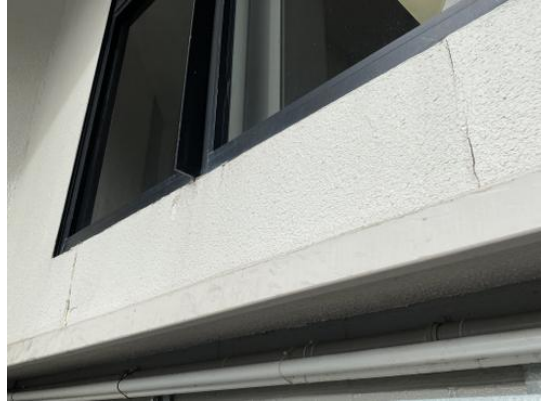
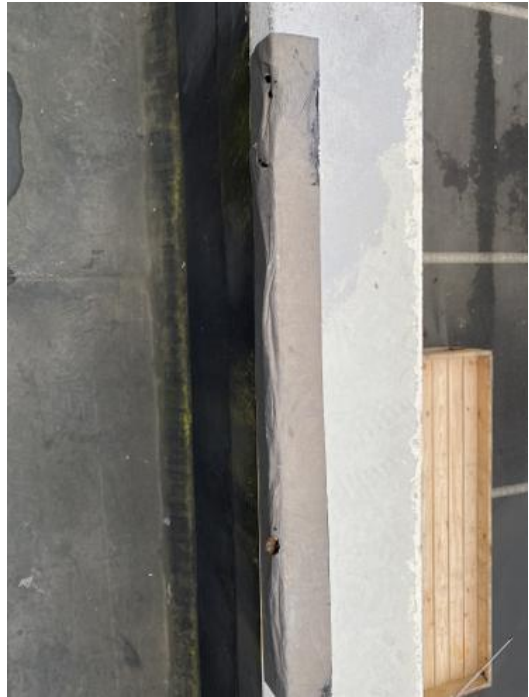
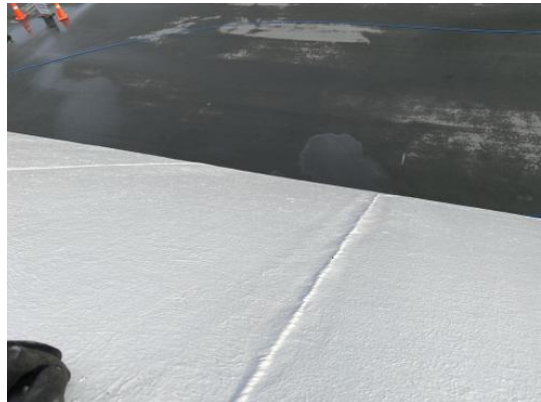
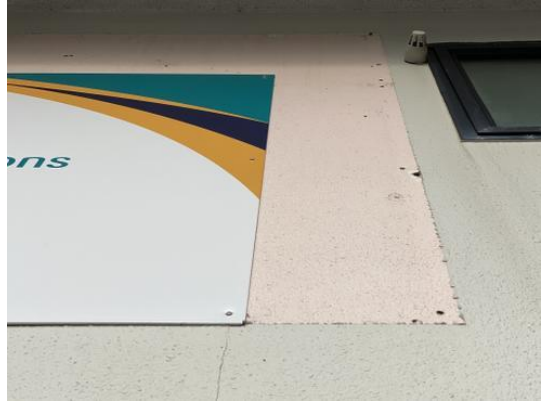
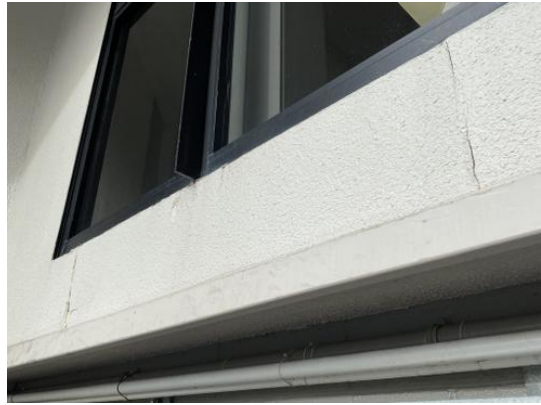
Damaged or failed building materials;
broken, rotten or impact

Weathered paintwork / cladding

There are multiple areas identified where cladding has cracks or holes, it is advisable that these be repaired.

- The parapet wall appears to be made from steel frame construction as per rust that is visible where water egress is present (would be good to confirm on plans). It has been suggested that expansion joints and repaint is done here before further failures occur. Something to think about in budgeting.

- There are a few other areas where holes and cracking has occurred. The northern end of the complex in particular this area could do with sealing up. Let me know if you would like a PC Sum indicated.

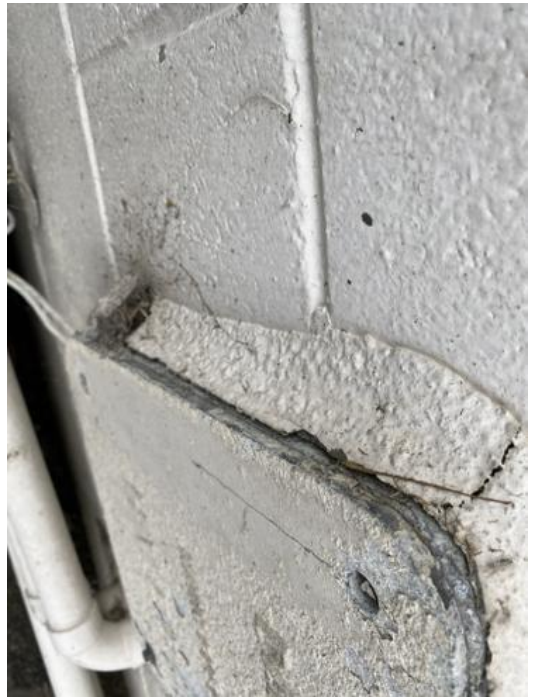
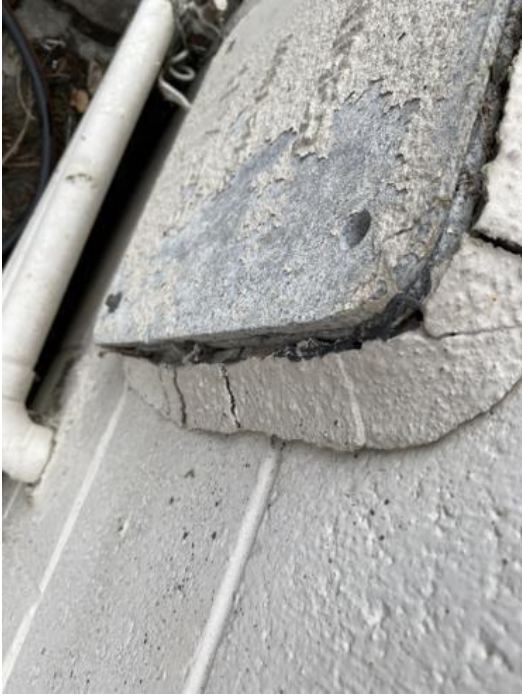
Electrical issue

Sealant in need of repair

Electrical Mains in box, is showing wear and cracking around seal and could do with re-sealing.

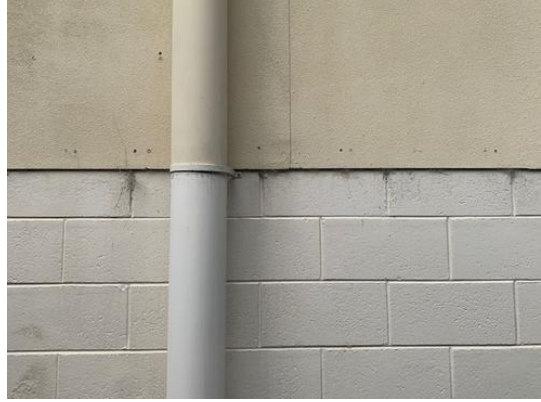
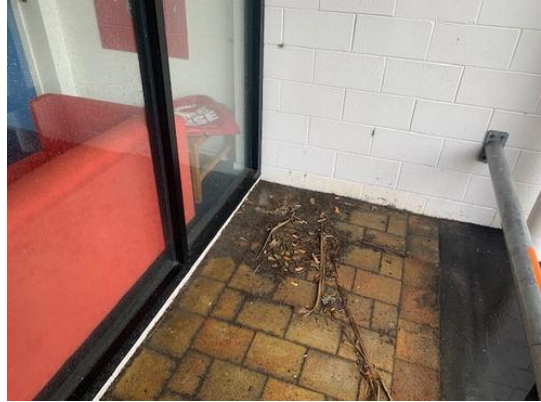
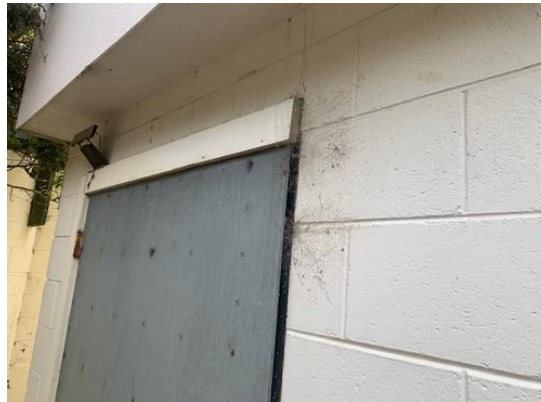
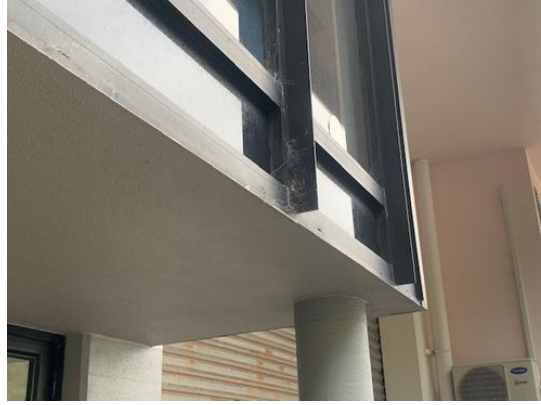
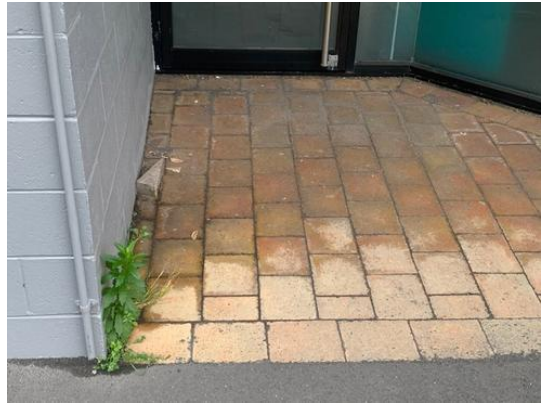
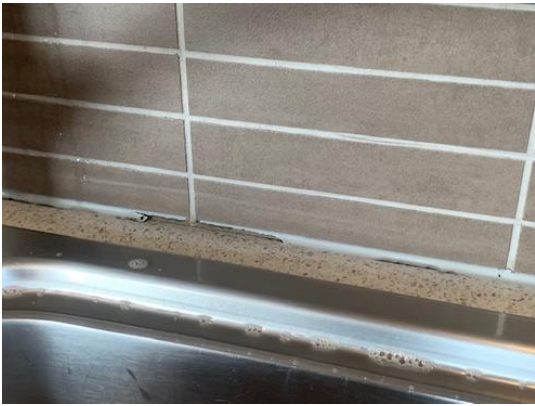
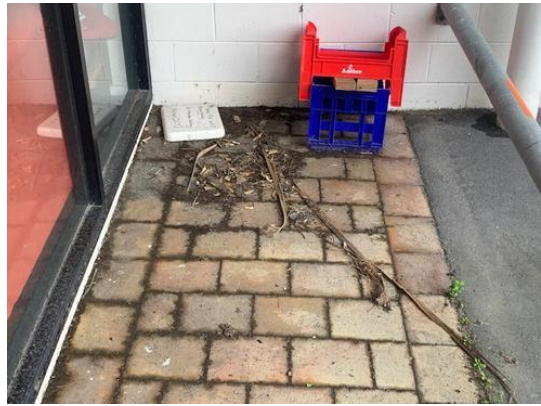
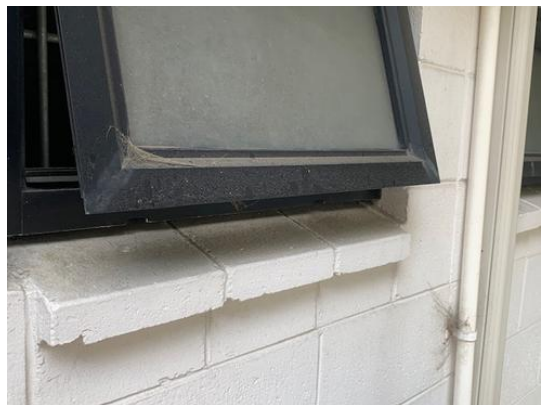
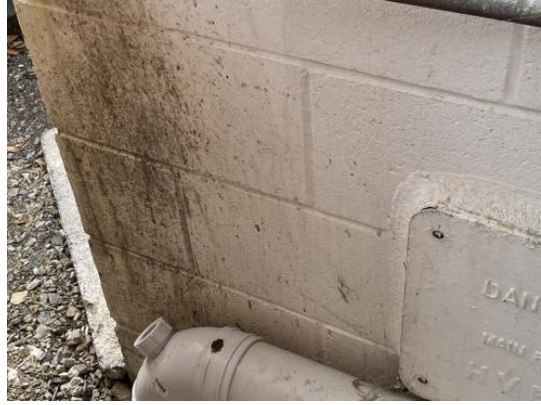
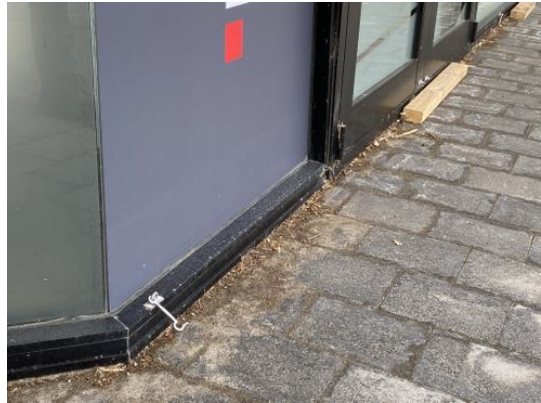
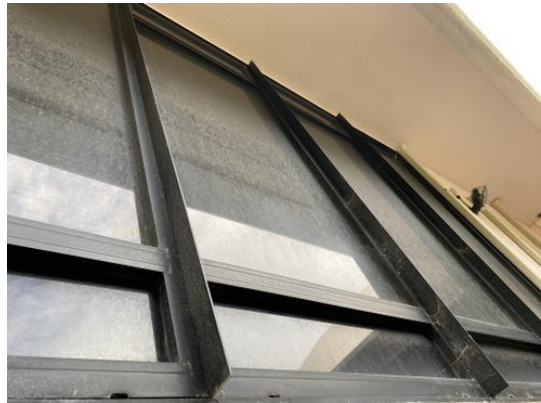
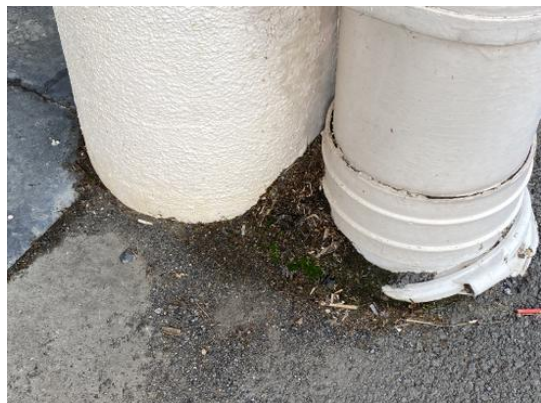
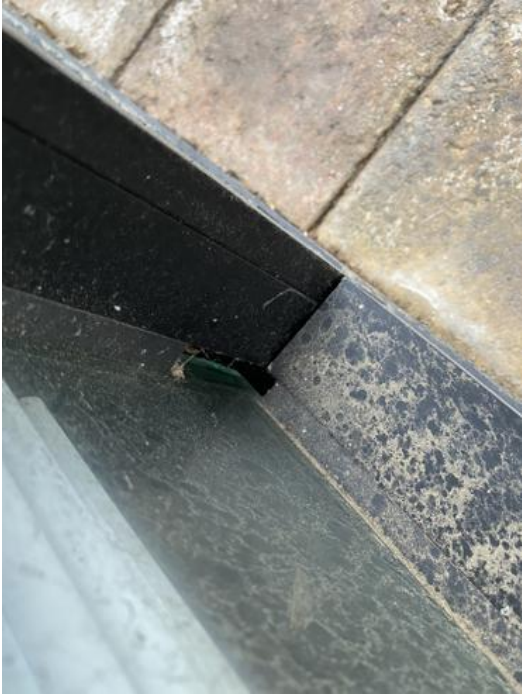
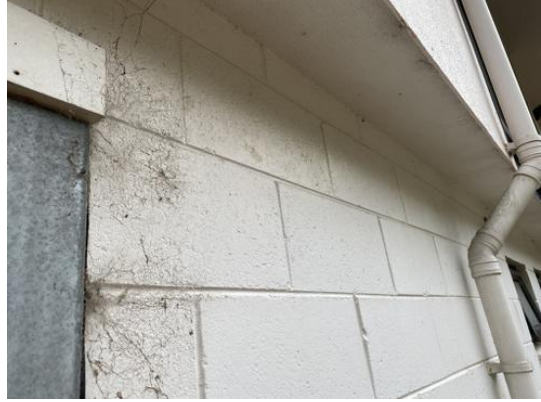
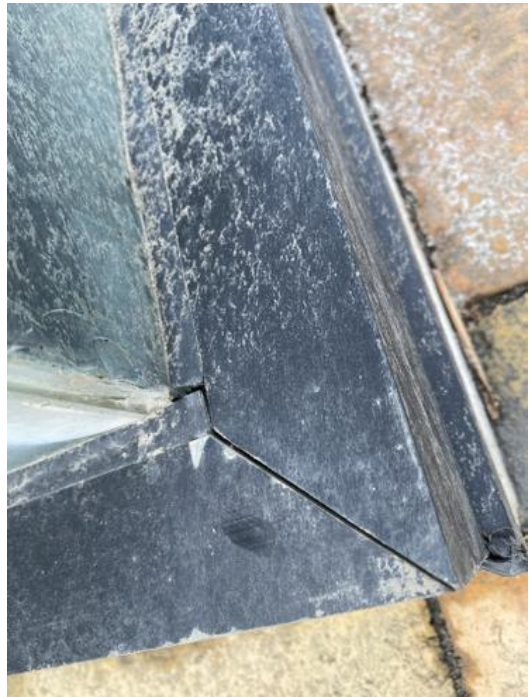
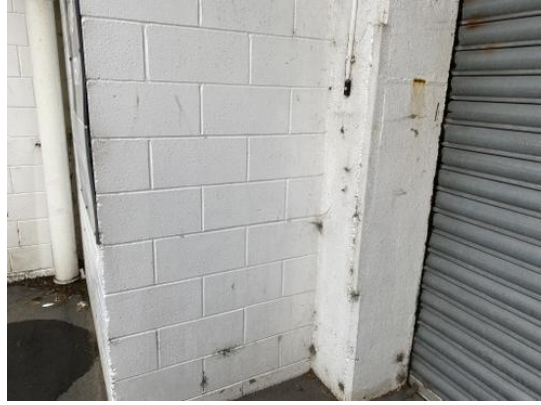
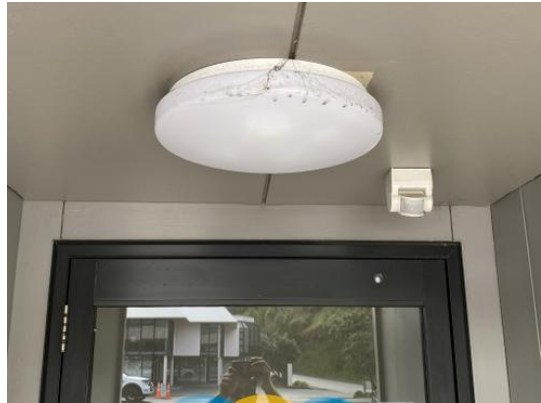
Environmental grime build up

Birdstrike, Spider Or Vermin issues

- Normal 6 monthly buildup of environmental Grime and Salts built up and removed.

- Normal amount of Spider infestation. would benefit from a spider control treatment. Please advise if you would like this done.

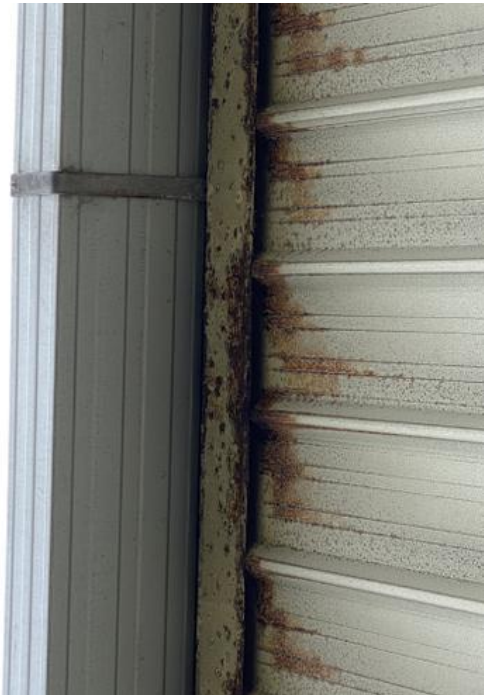
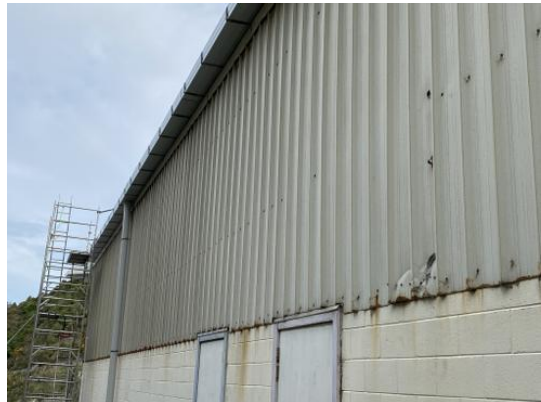
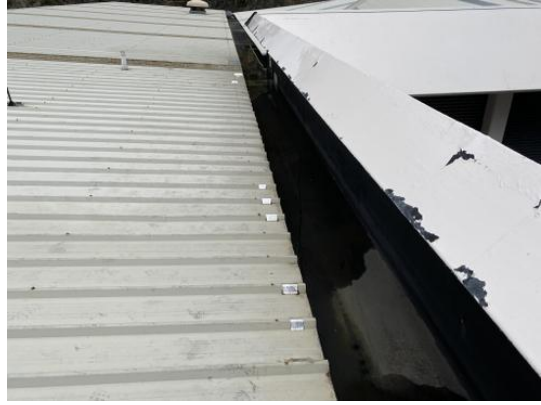
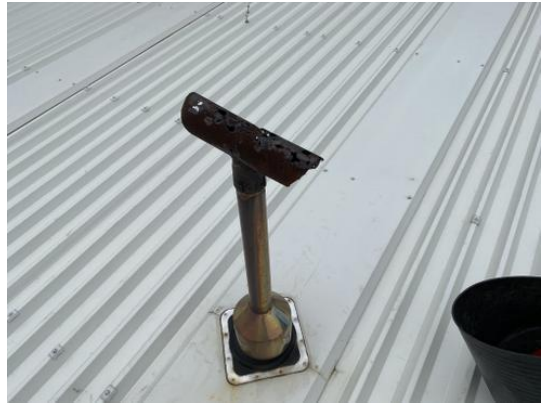
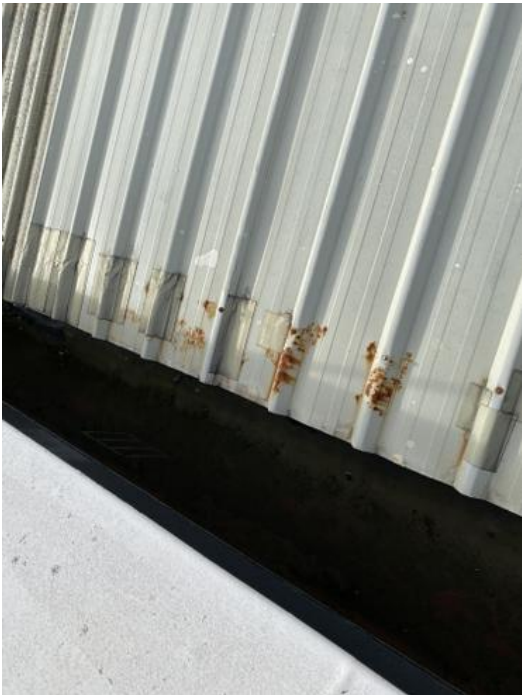
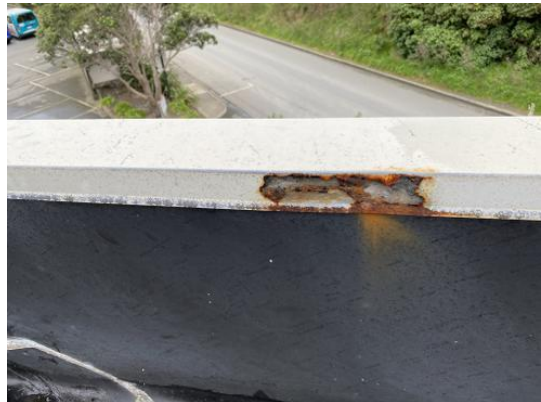
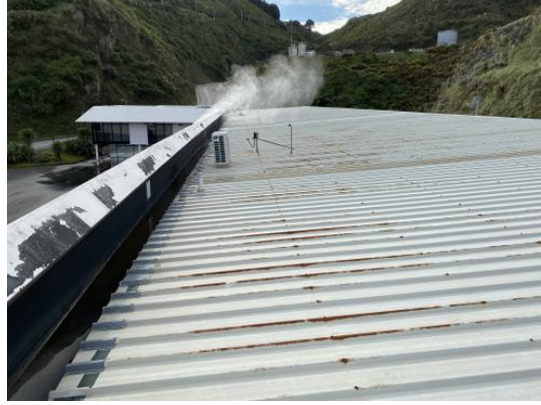
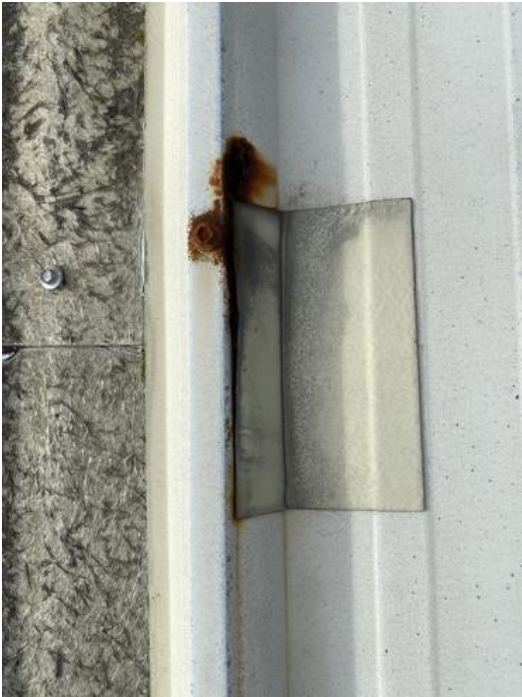
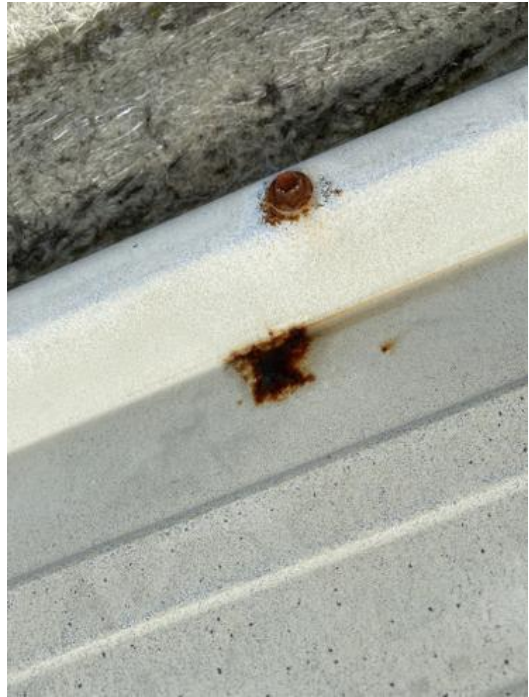
Rust

- Heavy Rusting on un-weathered areas at the rear of the complex. (Not currently washed down). Please advise if you would like this done.

- Roof has a few rust holes present at the Northern end of the building. Temporary Patching could be done here.

- There is a vent above harbor city security business that has substantial rust.
