Project report: Renovating and adding a Passive House annex to an apartment building in Kollwitzstrasse 1 – 17, Nuremberg

Dr. Burkhard Schulze Darup

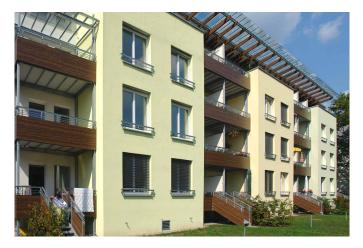
Figure 1: View of building after renovation.
